Re: Minor Municipal, SIC 4952, NPDES Compliance Evaluation Inspection, Chama Wastewater Treatment

Plant (WWTP), Chama, New Mexico, NM0027731, May 28, 2013

Compliance Evaluation Inspection Chama Wastewater Treatment Plant NPDES Permit No. NM0027731 May 28, 2013

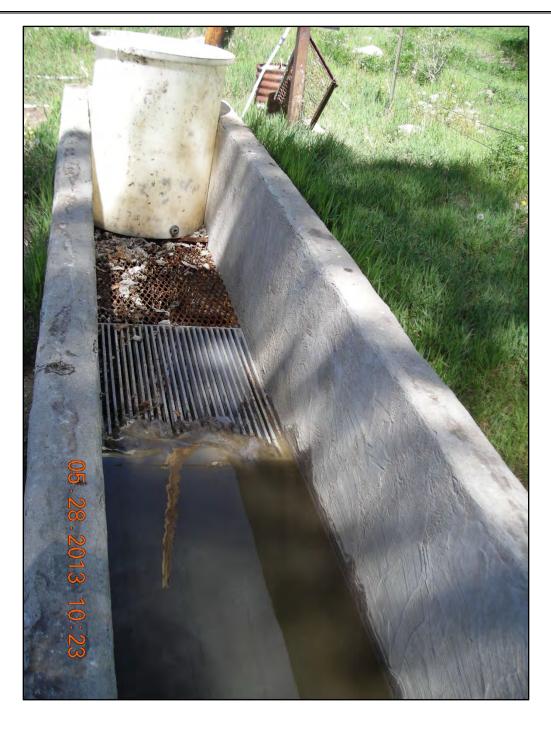
Photo # 1

Subject: Influent channel and ¾" bar screen. There is no flow measurement equipment functional at the influent channel.

There is basically no influent flow monitoring system set up at the facility. There is no flume at the influent portion of the plant, and the totalizer meter installed in 2009 that was once operational is no longer in service. At the time of this inspection, work was being done to correct the totalizer meter.

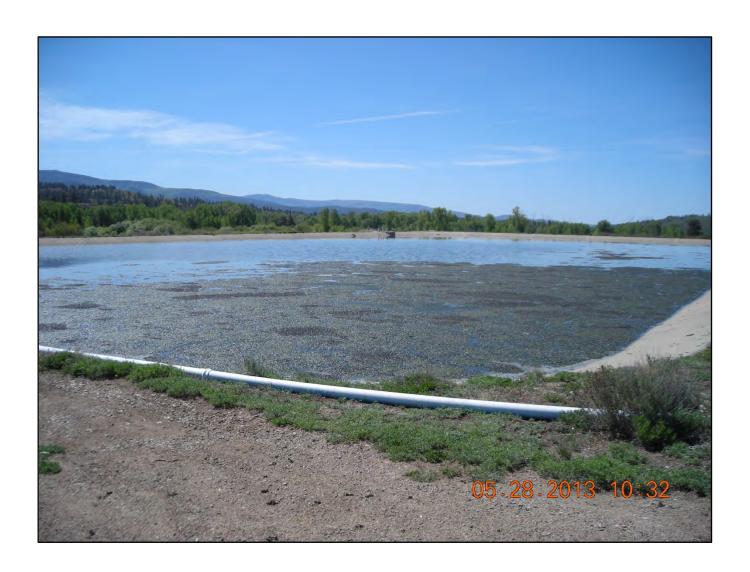
Photo # 2

Subject: Western pond of the lagoon system. Note the algal growth occurring from turnover within the ponds (seasonal temperature change).

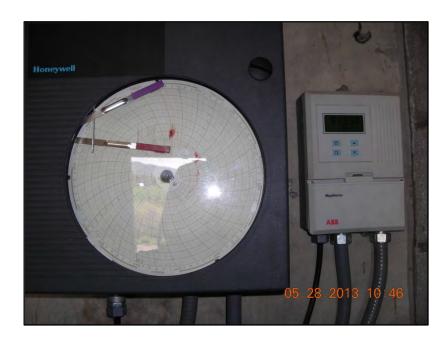
Photo # 3 & 4

Subject: Old influent flow meter (left) which is not currently functional. The new totalizer installed in 2009 is on the right. The meter fluctuated between reading out a number and showing zero flow at the time of the inspection.

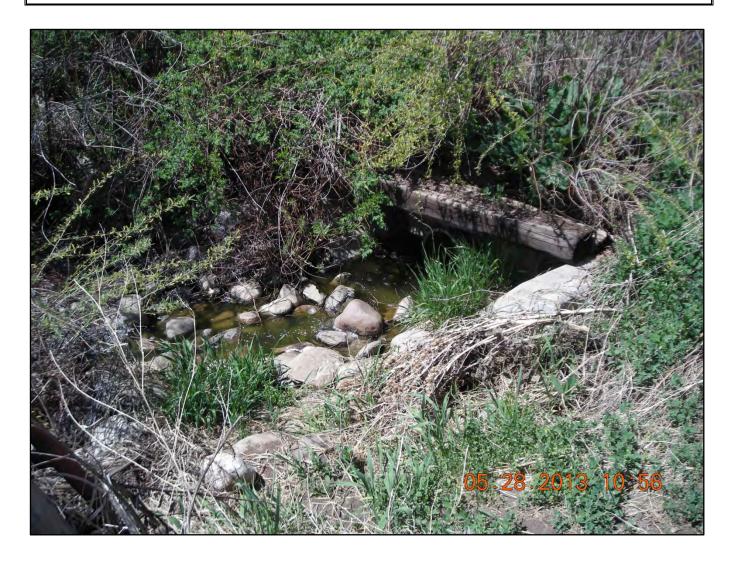
Official Photograph Log Photo # 5

Subject: Effluent pipe and channel prior to entering the Rio Chamita.
